SLOPE STABILITY STUDY OF TALANGI CHROMITE MINE

Singh V. K.

CSIR-Central Institute of Mining and Fuel Research (CSIR-CIMFR), Dhanbad.

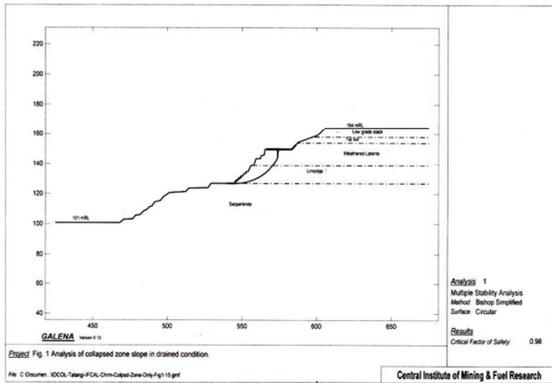
Fig. 1 Stability analyses of failed mine slope

The stability analysis shows that factor of safety of the most likely western failed slope profile just before the failure was 0.98 (Fig. 1). The minimum factor of safety for long term slope stability in mines

The slope angle of the failed zone was about 44 degree. The benches in the limonite are made manually and are having less exposed width. It resulted in localized steeper slope, which was more for long term slope stability. It resulted in high stress development.

The area experienced unusual heavy downpour before failure. It shows that the heavy rainfall had occurred just before, during and after failure. It was observed that the drains along the crest and toe of the failed zone were got blocked at few locations. It would have resulted in stagnation of water at these locations, which would have been resulted in water saturation in the relatively steep slope mass. It was observed that base of failure was along the contact of loose limonite and hard serpentinite. Due to differential permeability between soft and hard lithology, the water flow through it would be slow. The contact zone would be saturated due to differential permeability between two layers. It results in saturation of soft layer along the contact of soft and hard lithology.

The relatively steeper slope failed due to saturation after heavy rainfall and differential permeability between soft and hard lithology. The failed mass should be pushed back to form new benches.

The failed zone should be reformed by pushing back the benches. The push back

should be sufficient so that the final benches are formed in in-situ mass.

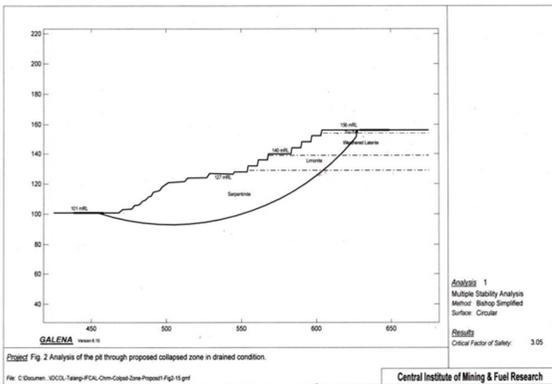
Fig. 2 Stability analyses of reformed mine slope

The analyses show that the proposed / planned bench profiles (Figs. 2 and 3) of the pits are likely to be stable. The stability analyses were done with a consideration of controlled blasting on the hard serpentinite slope faces and proper drainage for rainwater and groundwater. The optimum bench design of final slopes has been presented in Table 3.
