# STABILITY OF TRADITIONAL ‘BUNDHS’ - EARTHEN LEVEES - FROM GOA

**ABSTRACT:** Goa is a land reclaimed from the sea thousands of years ago by traditional rubble-faced-compacted-earth retentive structures called ‘Bundhs’ - earthen levees embankments and revetments. These have lined, shaped and protected the low-lying Agricultural Lands, Canals, Lakes and Seashores. They have survived through millennia by steady Community-based repair and maintenance programmes. These walls have survived floods, earthquakes, and even foreign conquests. There is a concern on flood, erosion and riverside stability issues due to the risks that are compounded by the destruction of these traditional retentive structures. Much can be learnt from the traditions of our culture when tradition and technology goes hand in hand. This paper studies the stability of these traditional structures. GeoSlope is used to check the slope stability of the structures. The factor of safety was found out to be higher than 1.5 even in rapid drawdown condition for various configurations. The construction practices discussed further supplemented the strength and stability thus longevity and utility of these structures. There is

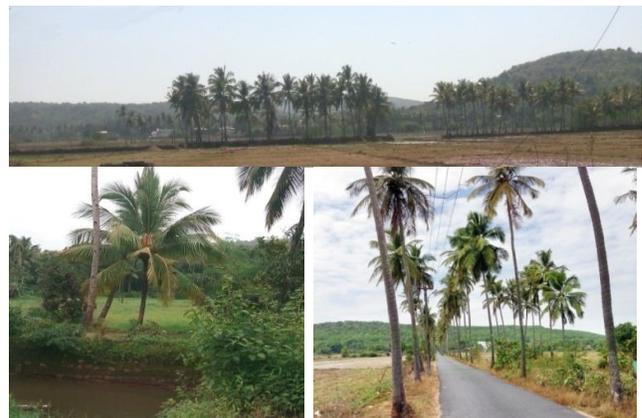
Figure 1 Photograph of bundh

As witnessed from Saraswati (Indus) Valley civilization onwards, Indians have used earth for civil engineering especially geotechnical purposes. Mohen-jo-daro even today is protected by a bundh 15,000 years old. Legend has it, that when River Saraswati was swallowed by mother Earth, 96 prominent Saraswat clans settled in Goa bringing along with them their Civil technology especially the bundhs (earthen embankments and levees) that were used to reclaim the land from the sea (Mukhopadhyay, 2002). The uniqueness of this fact is even reflected in CRZ notification that dedicates a special section only to Goa. These ribbons of earth topped by coconut trees (Fig. 1) are found all over Goa.

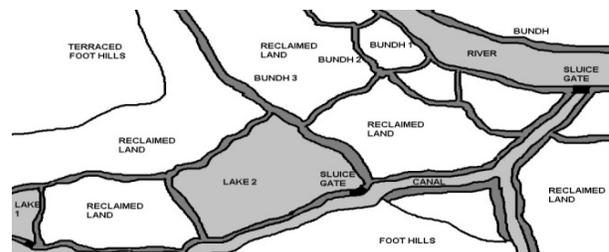
Figure 2 Schematic location map

The landside was level and confined within ring-bundhs and secondary bundhs. The bundhs parallel the river and hill contours as applicable. The general slope of the reclaimed land was terraced in steps and staged (Fig. 2) between bundhs to approach low tide level at inner face of river side bund.

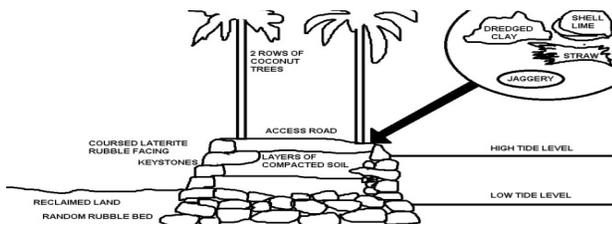
Figure 3 Bundh construction

Primary Constituents of the bund were dredged clay from river bed. It was stabilized with burnt-shell-lime. The plastisizer used was coconut jaggery molasses. Cow dung and coconut leaf ash was used to increase cohesion and manage fine contents if the soil was too sandy in nature. Layers were laid in lift of 30 cm with rice-straw in-between. Rice straw layers were used as initial geofabric. Facing layer was made up of interlocking coursed lateritic rubble masonry. Compaction was done by using a line of 4 to 6 bullocks walking in a line. The compactive equivalent of 2-3 tonne sheep-foot rollers doing 10 passes per layer. Two lines of Coconut trees were planted on either side as a natural geogrid, to reinforce the structure by their fibrous root system (Fig. 3).

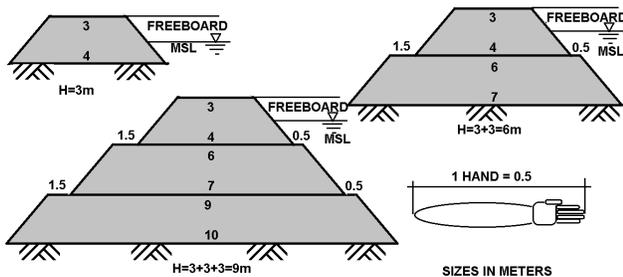
Figure 4 Typical Bundh sections showing maximum sizes.

Typical traditional unit of measurement was 'hatt'-one hand (approx. 50cm). Bamboo of required size was measured and cut and used for checking the size. Face inclination is generally 0.5-H : 3-V. while benching offset on seaward side is usually 0.5 m. and the offset on the leeward side is 1.5m. A freeboard of 1.5 to 2m was maintained for tidal fluctuations and flood absorption (Fig. 4).

As the bundh toppers were parallel to water level, simple tape measurements with plum-bob were used to measure cross sections. Most bundhs were found to be 3m wide and depths varying from 1 to 3 m. in rare cases as heights increased there was stepped berms (banquettes) as detailed in section 2.2 and Fig 4.

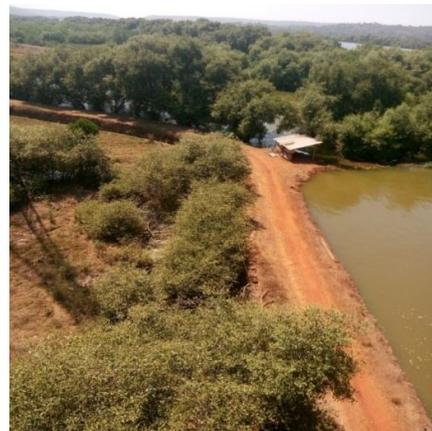
Figure 5 Invasion of mangroves, flooded outer bundh and disappearance of coconut trees at Borim on Mandovi river

There are numerous negative effects of bundh damage: Invasion of mangroves, Changes of shoreline, flood, erosion and riverside stability issues, Disappearance of ancient historical technology (Fig. 5).

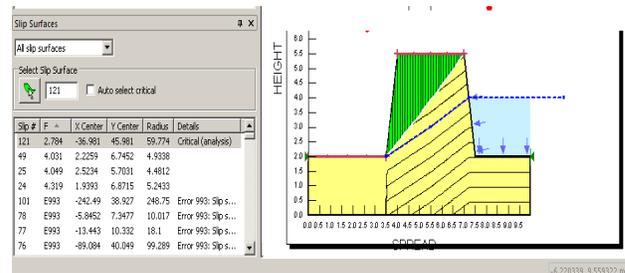
Numerical analysis was done using commercially available software GEOSTUDIO-SLOPEW (Ikiensinma, 2005) showed factor of safety above 1.5. (Fig. 6). The Morgenstern-Price Method of slope stability was chosen for the software and the  $\gamma$ ,  $c$ - $\phi$  values chosen were the same as for slip circle analysis.

Figure 6 Screen shot from Geo-Studio leeward side showing FoS = 2.784

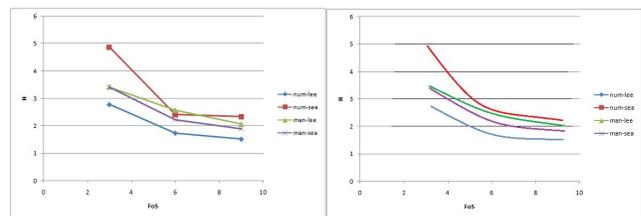
The factor of safety from both the slip surface analysis (Table 3) and the Numerical analysis (Table 4) were plotted on graphs and showed that the reduction in the values of Factor of safety with height of the embankment is a curve that levels out at 1.5 for worst case scenario. (Fig. 7)

Figure 7 Graph of Factors of safety
