# ROCK MASS SLOPE STABILITY ANALYSIS UNDER STATIC AND DYNAMIC CONDITIONS IN MUMBAI, INDIA

**ABSTRACT:** The rock slope stability has gained much importance in the recent years owing to the development of infrastructure in/on rock slopes areas in the form of high rise building, roads, railways, dams and other rock engineering projects. Rock slope stability is generally affected by the property of rock material along with the discontinuities in the rock mass. It is also dependent on slope angle, slope height, surcharge, ground water conditions, rain fall, and dynamic forces like earth quake. If this factors coupled with deep weathering of the rock mass, complicates the entire behavior of the rock slope and makes the analysis of rock slopes challenging task.

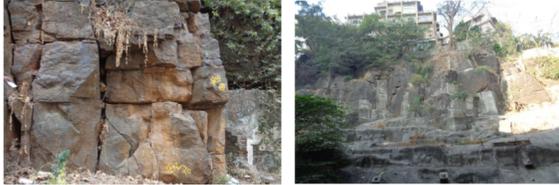
Fig. 1 The present Rock slope appearance on out crops from eastern to western corner of the slope (a) dominant joint sets, discoloration and staining of rock material due to weathering clearly visible (b) already stabilized portion of the rock slope.

The rock slope is located at the eastern scarp of Cumballa Hill in Tardeo, Mumbai. Regionally the Rocks in Maharashtra and around Mumbai are of volcanic origin known as Deccan trap. The Deccan trap is composed of very hard, tough and compact rocks. The rocks are susceptible to weathering which begins on the exposed surface and along joints, cracks and fissures. With time it penetrates deep into the rock masses and resulting in complete loss of original skeleton structure

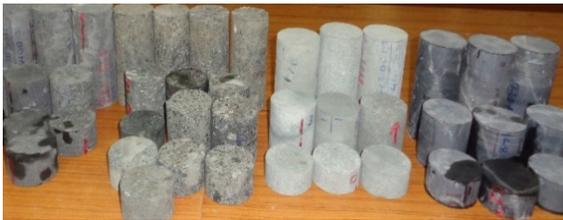
Fig. 2 Specimen prepared for testing under tensile, uniaxial and triaxial loading.

Rock material properties were obtained from laboratory testing including index properties tests, uniaxial, triaxial, Brazilian and point load test. The joint properties were calculated using direct shear test.
